Spot Safety Project Evaluation

**Spot Safety Project Evaluation of the Actuated Signal Installation at SR 1004 (W. Main St.)
and SR 1552 (Robertson St.) in Johnston County**

Safety Evaluation Group
Traffic Safety Systems Management Section
Traffic Engineering and Safety Systems Branch
North Carolina Department of Transportation

Evaluation of Spot Safety Project Number 04-96-235 – Actuated Signal Installation at SR 1004 (W. Main St.) and SR 1552 (Robertson St.) in Johnston County.

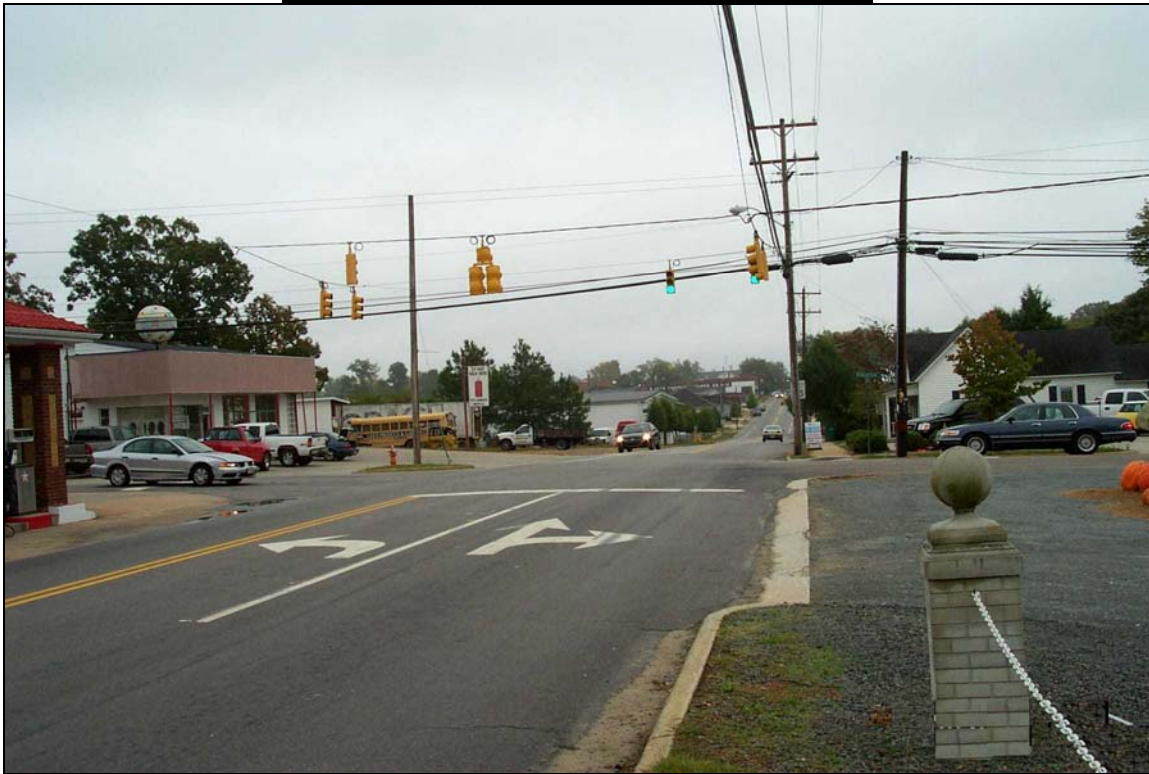
On SR 1004 facing east

During the site visit the only issue noted was a crest vertical curve at the intersection on SR 1004. Both the east (4%) and west (1%) legs have a downgrade away from the intersection. There is also a downgrade on SR 1552 from north to south. For vehicles crossing SR 1004 sight distance may have been an issue in the before period. It also seems vehicles may have had trouble recognizing the stop condition when approaching from the north. During the before period, the two backing crashes (crashes 20 and 21) may have been from vehicles stopping too late and having to back up to get out of the intersection.

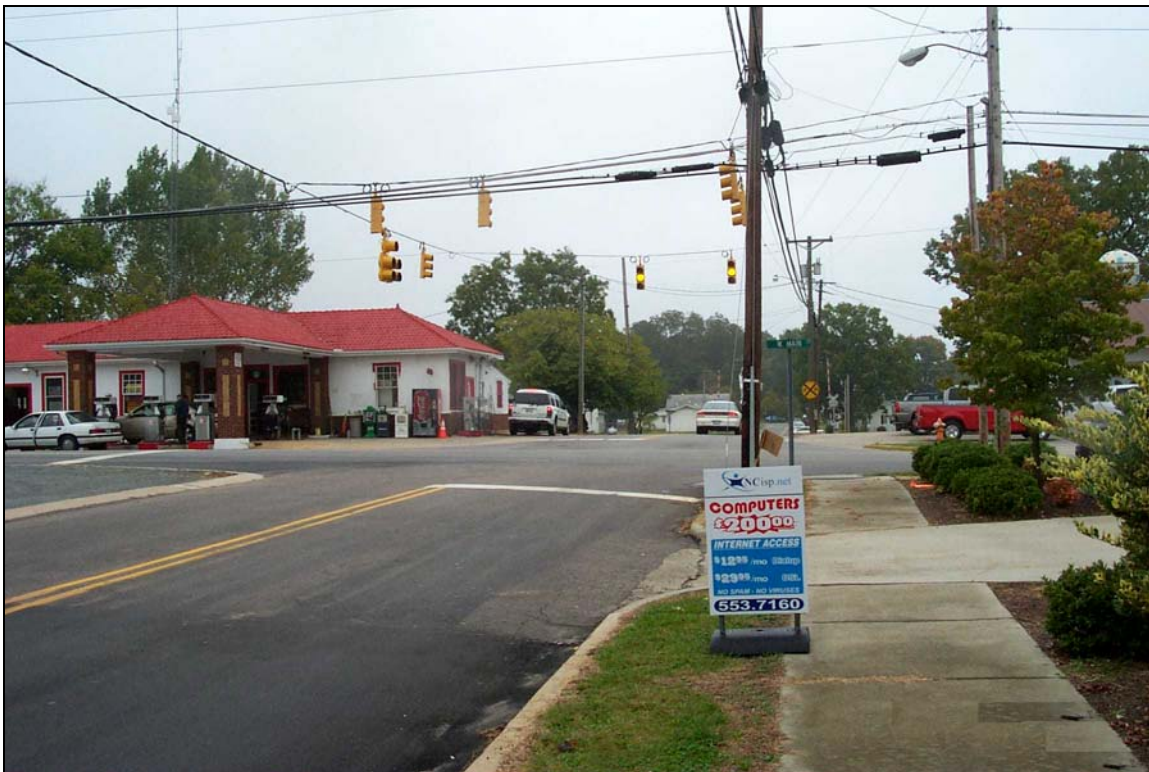
On SR 1552 facing north

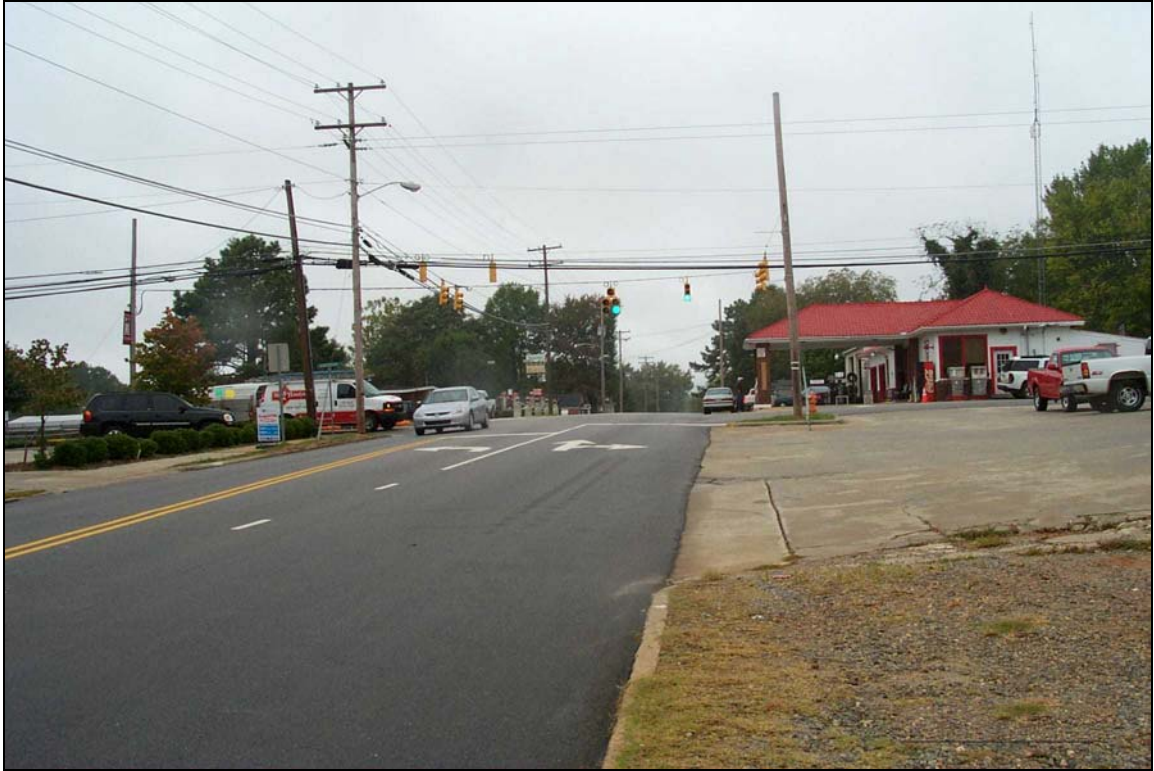
On SR 1004 facing west

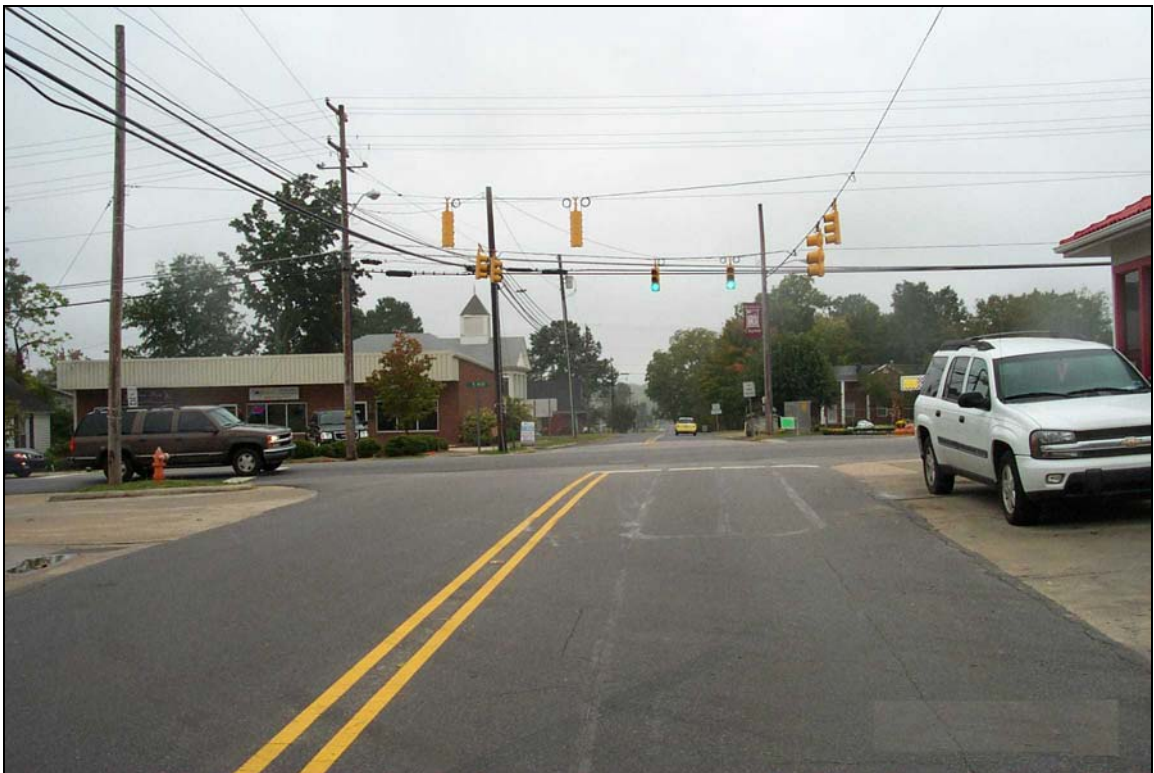
On SR 1552 facing south

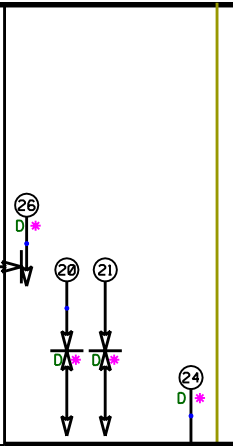
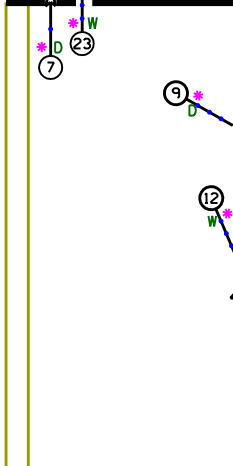
Johnston County
Treatment Site - Total Crashes
Before Period
January 1, 1990 - April 30, 1997
(7 years 4 months)

Referencing the before and after collision diagrams, left turning vehicles on SR 1004 may have difficulty finding suitable gaps in traffic for safe movement. The pattern still remains for vehicles turning left from eastbound SR 1004 in the after period. In the after period, there are 6 crashes for the eastbound left turning movement, which is 33% of the total crashes. During the field investigation, a protected left turn signal was in place for the westbound left turning vehicles. A protected left turn signal may prove beneficial for the eastbound leg as well.
